# **The risk of reactor pressure vessel material degradation**

## **Doel-3/Tihange-2**

Ilse Tweer

**NURIS 2015, Vienna, 16 -17 April 2015**

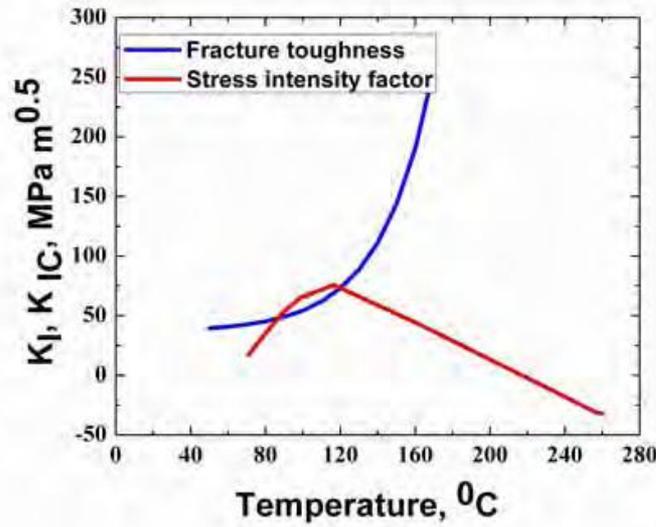
PTS analysis: comparison of the calculated load in case of an assumed transient on a postulated crack (stress intensity factor) with the materials properties (fracture toughness curve)

For safe operation the fracture toughness has always to be higher than the load path (the diagram shows that in a certain region of the accident progress stress intensity factors are higher than the fracture toughness of the material, there exists the hazard of uncontrolled crack growth)

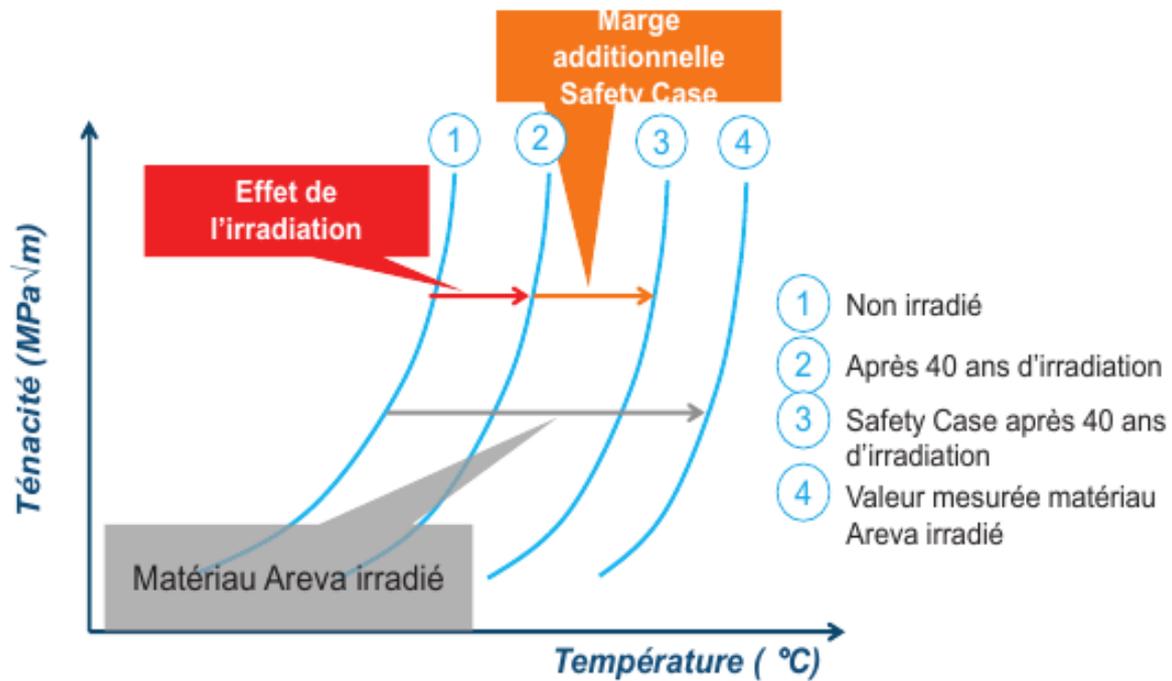
# Irradiation Results

- Electrabel proposed to add 50°C shift of the fracture toughness curve as safety margin covering all possible effects of defect density and irradiation
- The International Expert Group recommended a 100°C shift (this recommendation was eliminated in FANC's final report)
- Electrabel performed several irradiation campaigns in the research reactor Mol (very high neutron flux) because the data from the first irradiation campaign did not show the expected results
- The irradiation experiments were performed using samples from the AREVA shell VB-395, a rejected steam generator block. These samples cannot be considered to be representative for the RPV wall because the steel is certainly not identical, the manufacture processes and heat treatments are not identical and the AREVA block has no comparable operational history.
